# Interim Report

## **Monitoring and Evaluation of Thin Bonded Overlays and Surface Laminates for Bridge Decks**

**Montana Department of Transportation  
Research, Development, & Technology Transfer  
Program**

**August 1997**

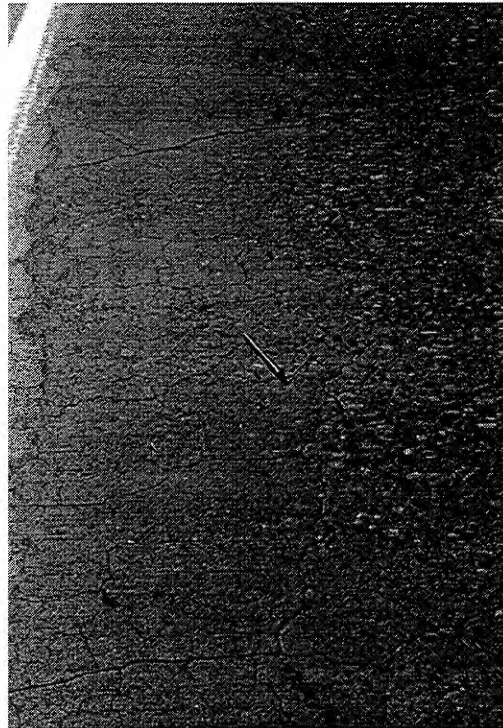
**Photo 2: Pre-installation, typical driving surface, Gallatin.**

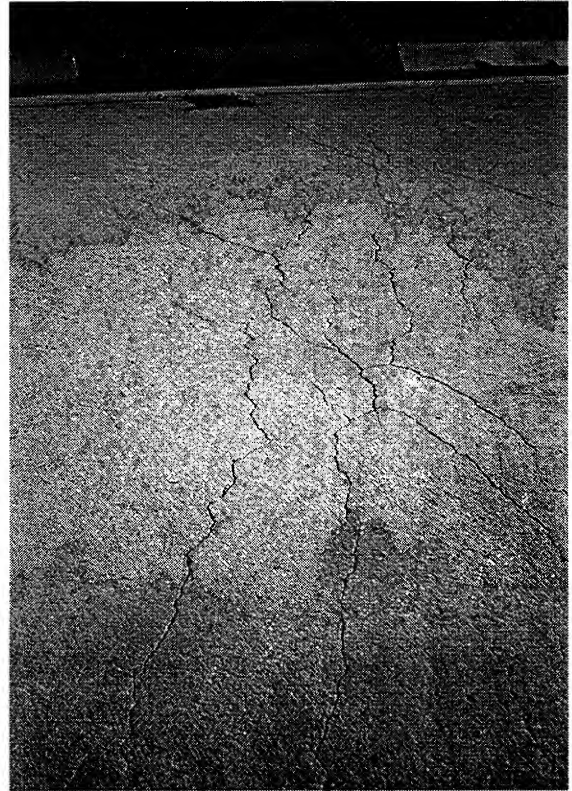
**Photo 6: Pre-installation, typical driving surface, West Garrison.**

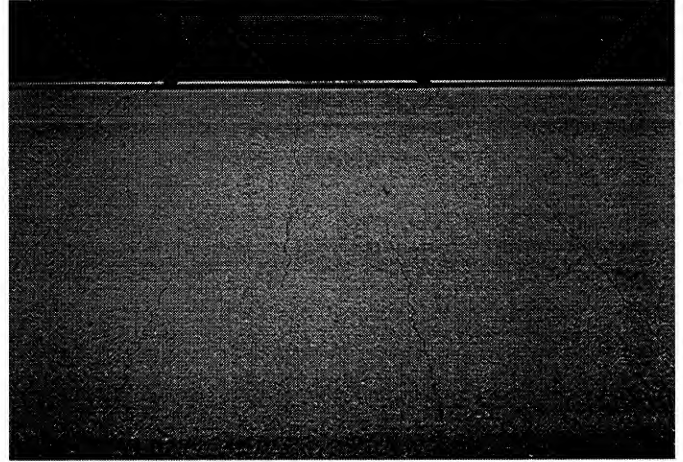
**Photo 15: Pre-overlay, surface, East Garrison.**

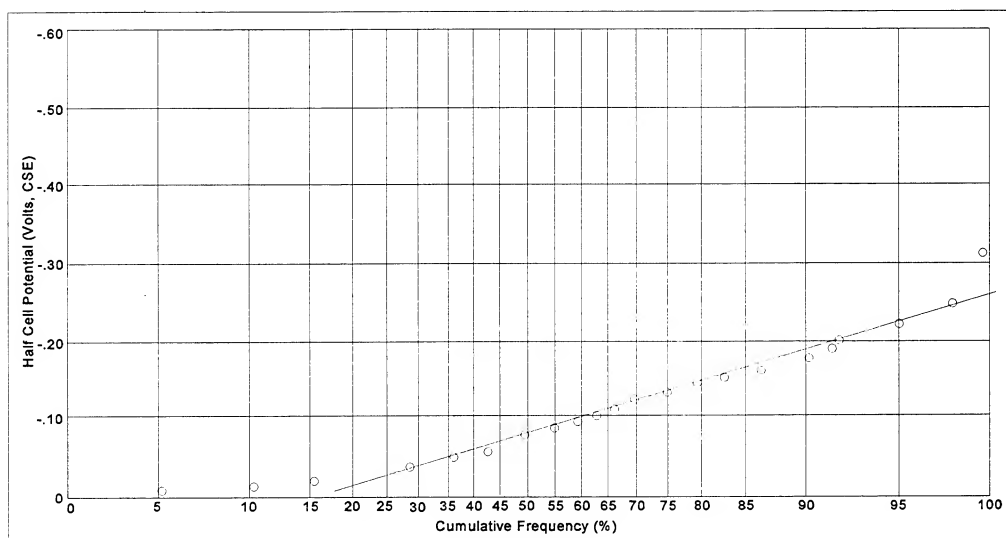
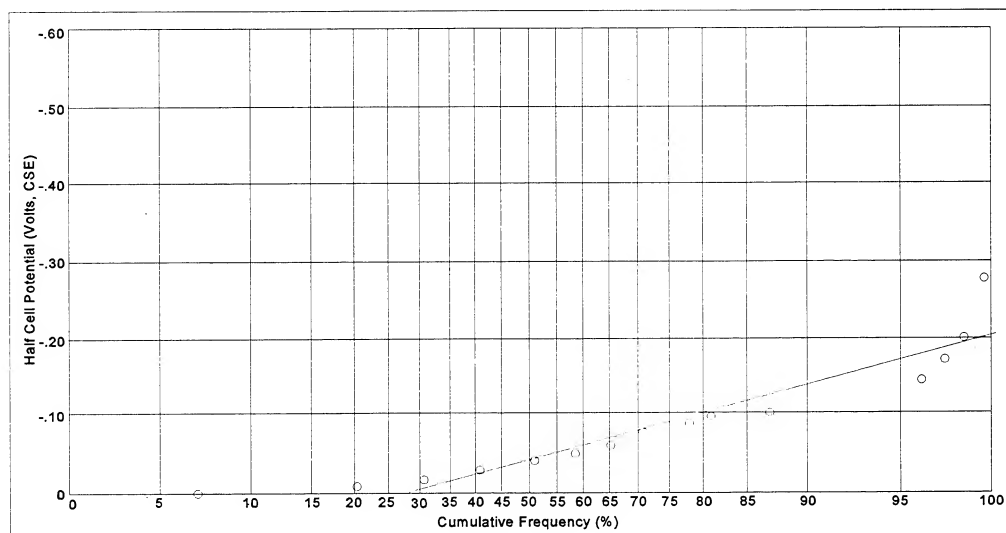
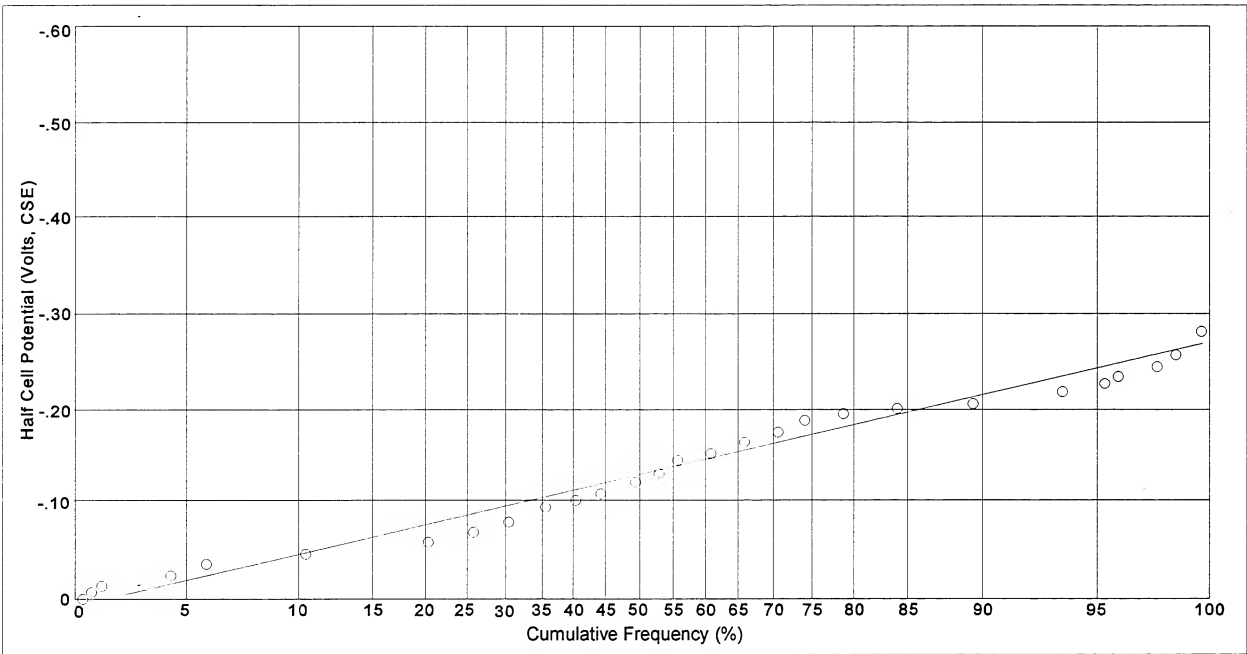
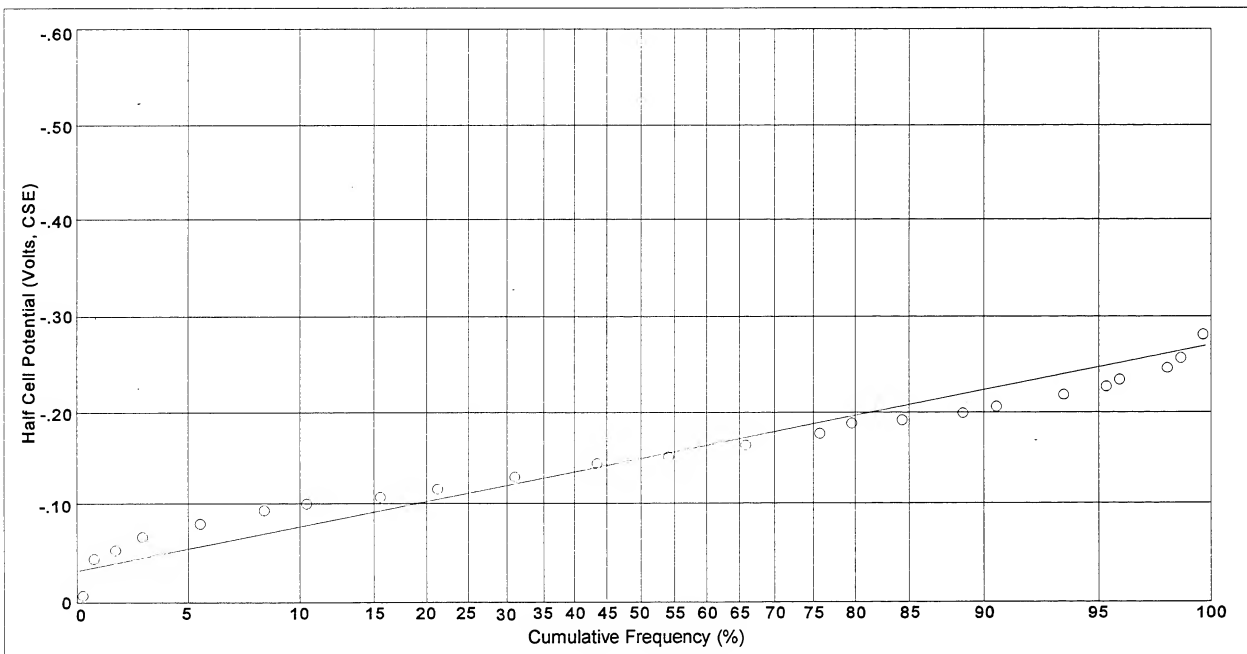
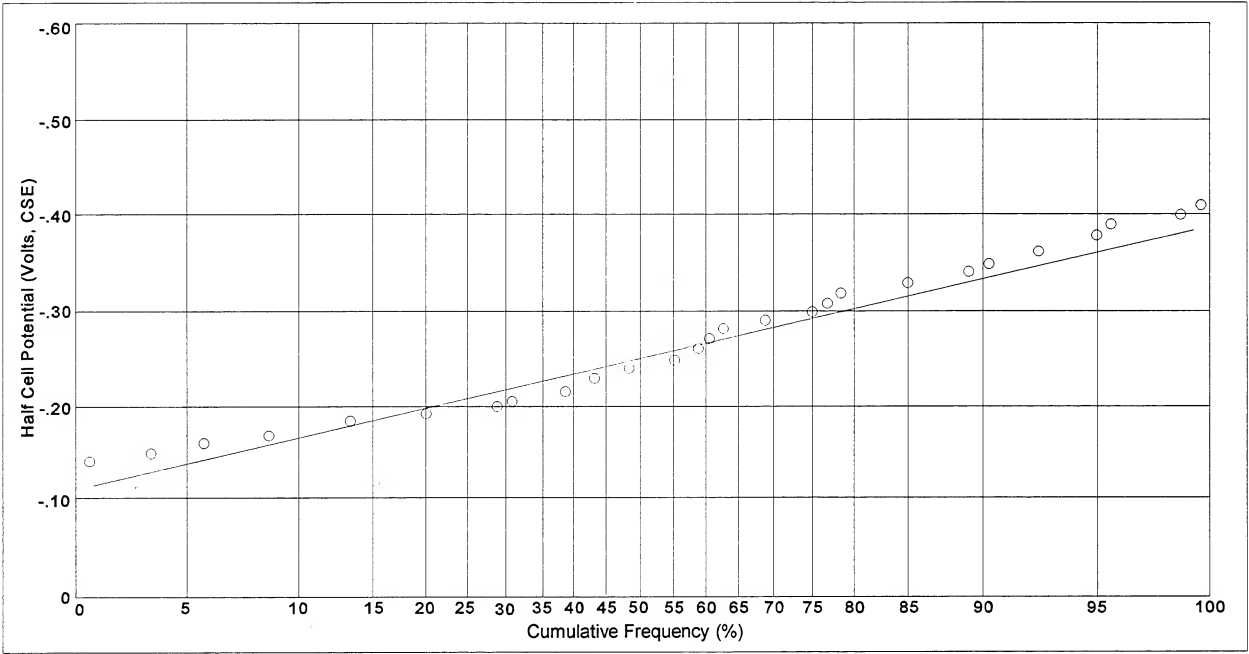
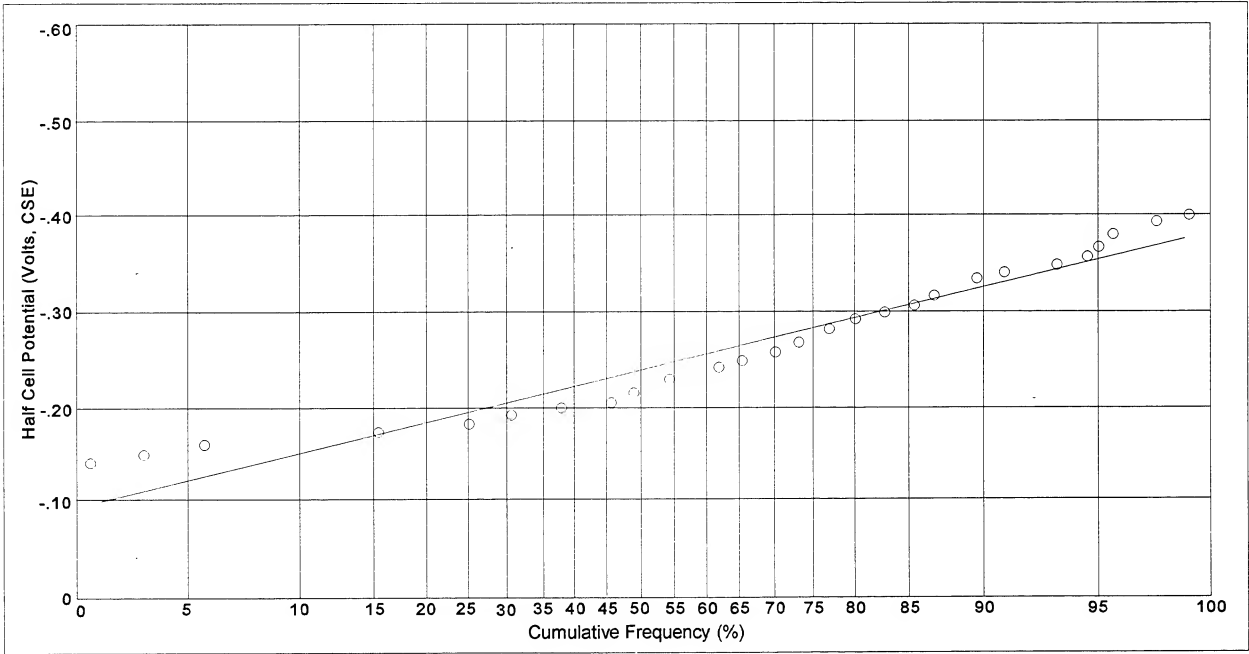
thresholds, the occurrence of corrosion is uncertain. Reviewing Figures 4.1.5 to 4.1.10, the occurrence of corrosion is unlikely over most of the West Garrison and Gallatin structures, as at least 85 percent of the reading were above -0.20 V CSE and 100 percent of the reading were above -0.35 V CSE. Some of the readings from the Galen structures indicate that corrosion was likely to have been occurring on parts of the decks when the readings were taken. Readings that would indicate corrosion activity ( $< -0.35$  V CSE) occurred over approximately 7 percent of the deck surface.

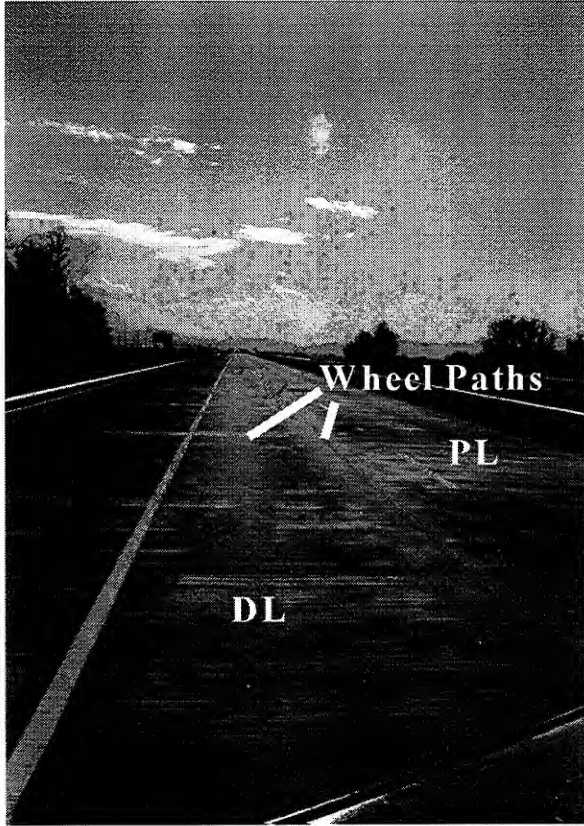
**Photo 20: Gallatin westbound, looking east.**

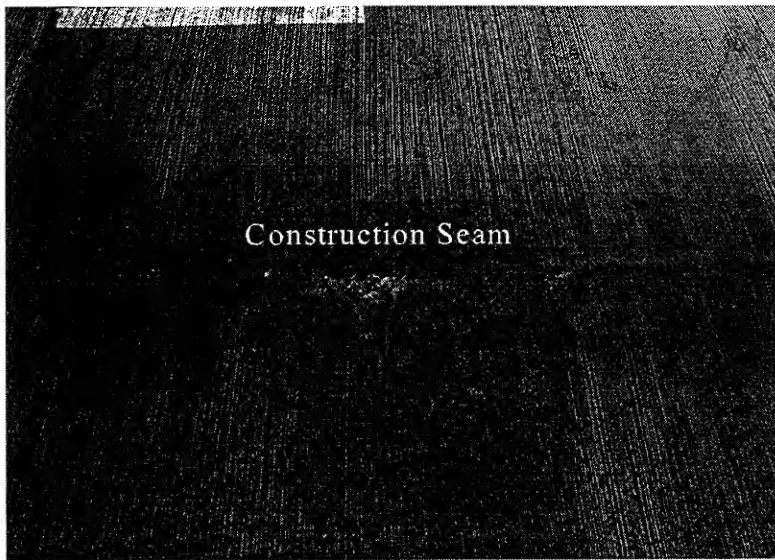
**Photo 21: Gallatin, surface condition.**

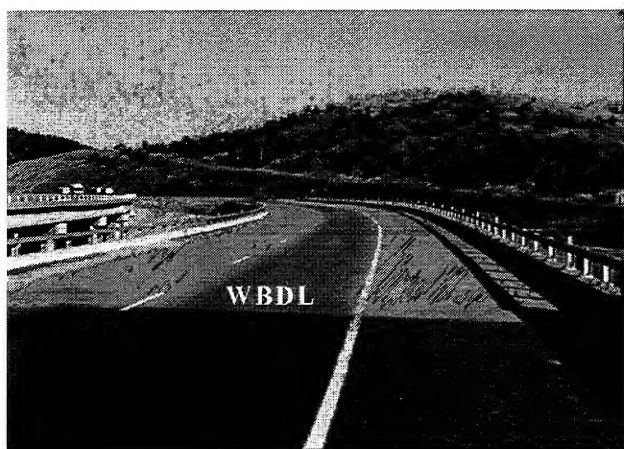
**Photo 22: West Garrison, westbound.**

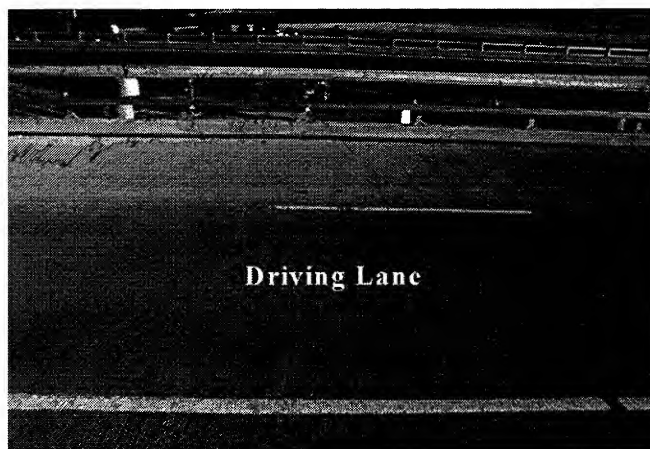
**Photo 23: West Garrison, westbound.**

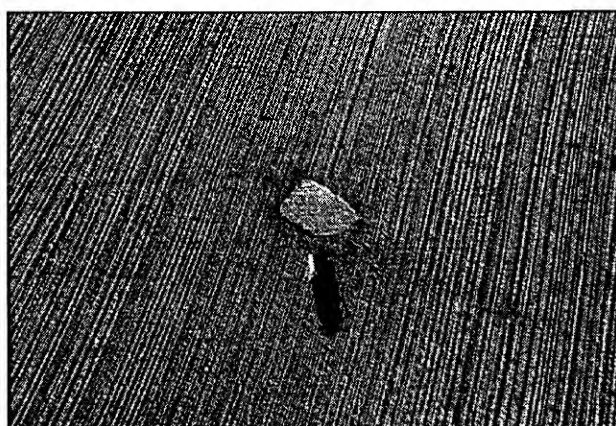
Figure 5.1.2 shows the condition of the Thorotop HCR structures at the West Garrison Interchange at the time of their first annual evaluation. Many of the distresses noted for the Gallatin bridges were also observed on these structures. Wheel paths were evident in the driving lanes. The pattern of smoothness observed in the wheel paths was similar to that of the Gallatin bridges. A number of delaminations were noticed at the expansion and construction joints. Additional delaminations were seen on the shoulders and on the driving surface on the westbound structure. Further analysis of the delamination locations revealed no correlation with pre-installation distresses. Marring from snow plow activity was seen. No cracking was observed on these bridges.

**Photo 24: West Garrison, delamination.**

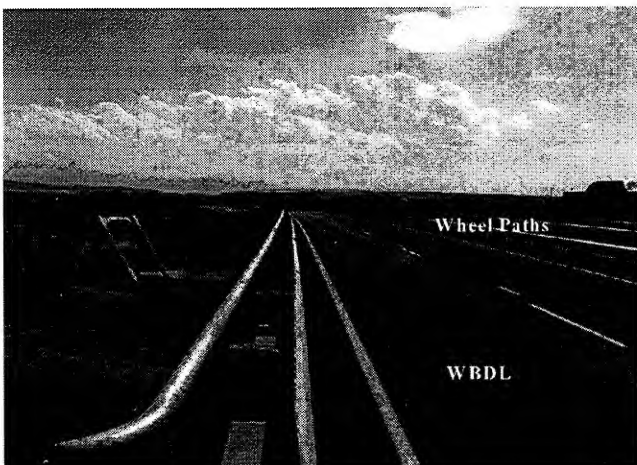
**Photo 25: Madison, westbound.**

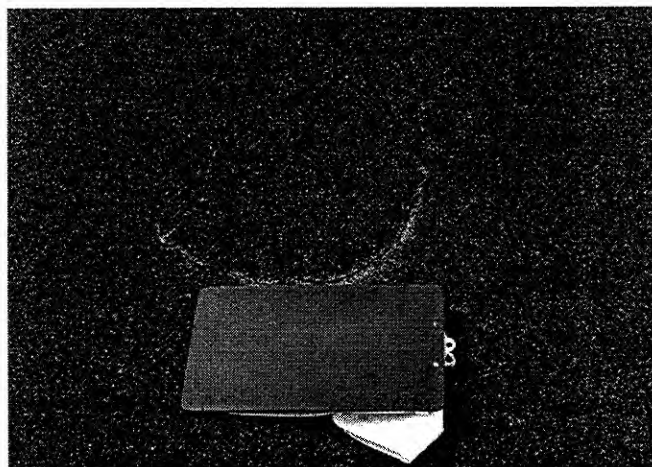
The first of the Flexolith 216 bridges evaluated was the westbound bridge at the Madison River near Three Forks (see Figure 5.1.3). As had been the case with all of the Thorotop HCR bridges, wheel paths were visible in the driving lanes, and the surface of the deck was smoother in these areas compared to the rest of the structure. This smoothness appeared to result from the loss of surface aggregate in the wheel paths. None the less, the Flexolith 216 wheel paths were noticeably rougher to the touch than the Thorotop HCR wheel paths. Areas where the aggregate coverage appeared inadequate at the completion of construction were conspicuous after one year. All construction seams were visible. Some reflective cracking could be seen above two of the bents in the driving lanes. An oval shaped crack, 12 inches by 18 inches, was found on the west end of the passing lane (see Figure 5.1.3, Photo 26). Surface marring, perhaps from snowplowing, was also seen. This marring was less extensive and less severe than was observed on the Thorotop overlays.

**Photo 26: Madison River, oval crack.**

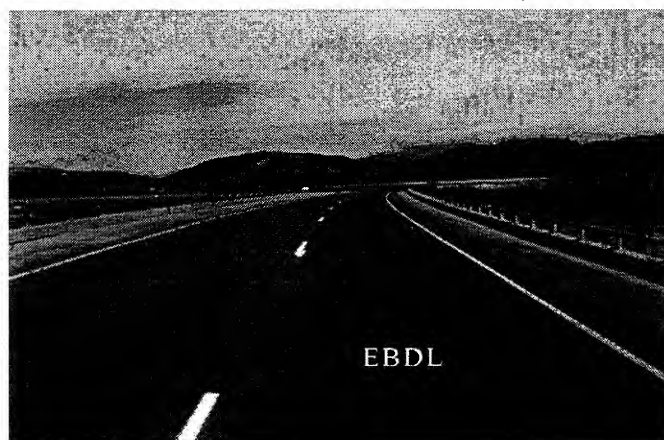
**Figure 5.1.4: East Garrison Photographs, Flexolith 216, First Annual Evaluation.**

The westbound and eastbound East Garrison bridges had many of the same distresses as had been seen on the Madison bridges. Removal of aggregate in the wheel paths once again resulted in a visibly smoother surface in these areas. A minimal amount of snow plow marring had occurred on both structures. No cracking was seen. Figure 5.1.4 further documents the condition of the East Garrison bridges.

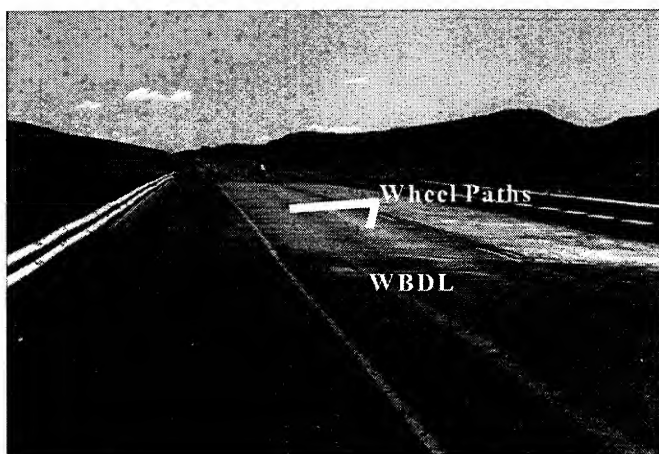
**Photo 29: Fairmont - westbound.**

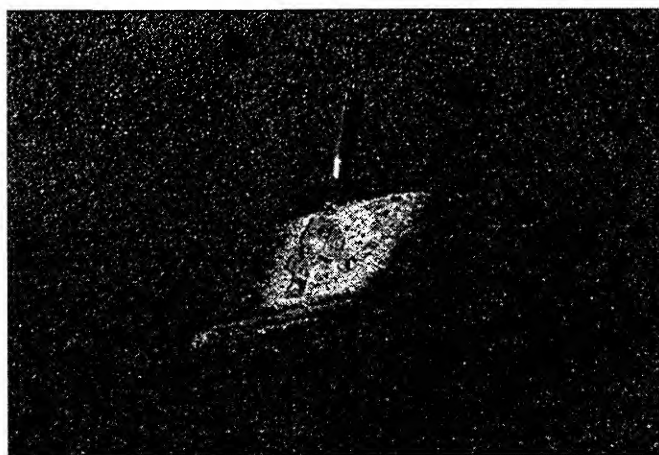
The only structures evaluated in 1996 that had received a Degadur MMA overlay treatment were those near the Fairmont Interchange. Both of the eastbound and westbound structures at Fairmont were performing in a similar fashion. While wheel paths were evident in the driving lanes, from general wear, the surfaces of the bridges were uniformly smooth to the touch across the entire structure. This condition appeared to be a result of the seal coat more so than poor aggregate coverage or removal. Popouts, as described in SHRP-P-338 (15), were noted on the surface of the overlays of both decks. Delaminations were found on both structures. Three delaminations were located on the westbound bridge; only one, on the eastbound bridge. While the sizes of these delaminations were not measured due to the high volume of traffic at the time of the evaluation, these areas were roughly 4 to 6 inches in diameter. The only crack found was on the westbound deck. It extended through the entire depth of the overlay at the approach guard angle.

**Photo 30: Fairmont Delamination.**

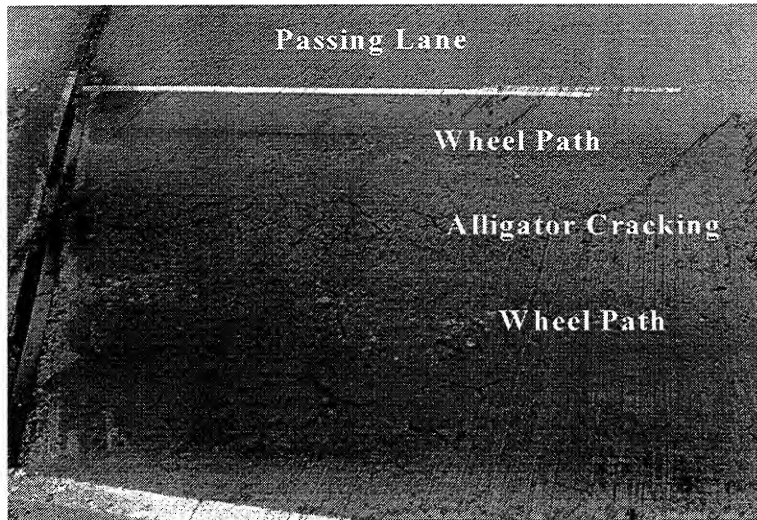
**Photo 31: Gallatin, typical driving surface.**

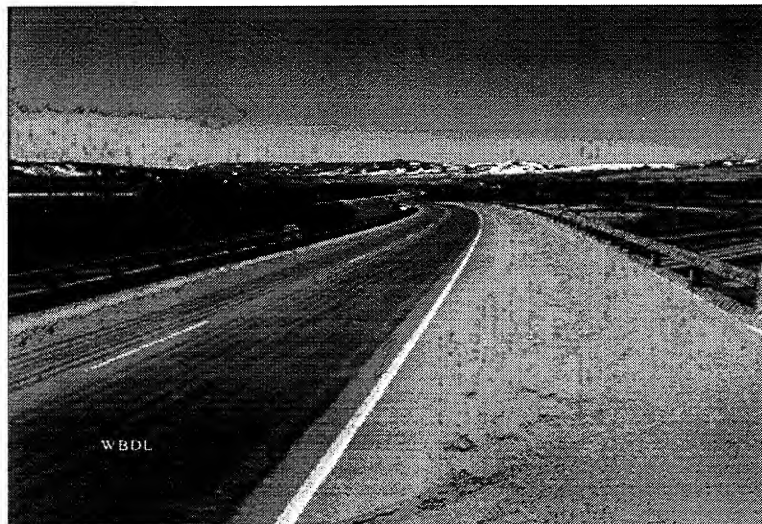
**Photo 32: West Garrison, westbound.**
